# PARKS POND DAM CT 00071

## PHASE I INSPECTION REPORT NATIONAL DAM INSPECTION PROGRAM

JULY 1980

Identification Number:	CT 00071
Name:	Parks Pond Dam
Town:	Danbury
County and State:	Fairfield County, Connecticut
Stream:	Parks Pond Brook
Date of Inspection:	April 22, 1980

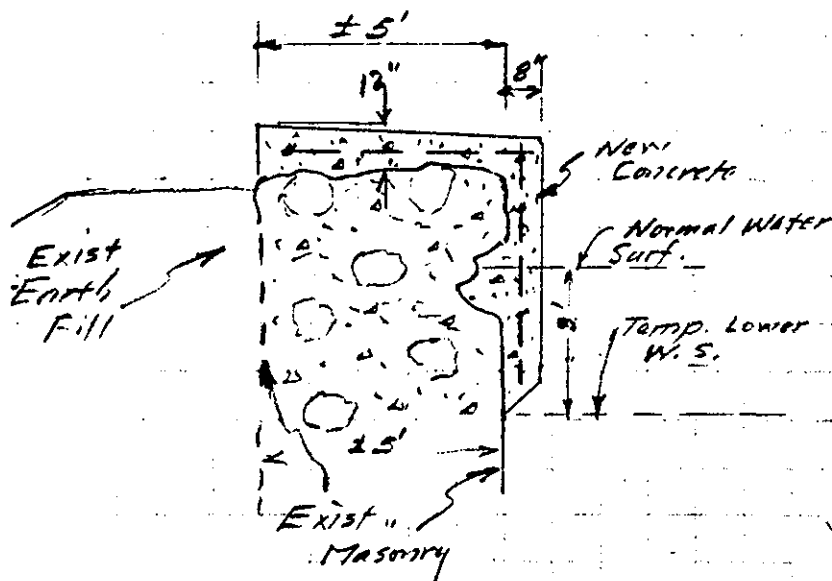
Possible Method of  
Repairing Masonry

There are no visible leaks thru or under the dam at this date. No cracks or displacement was observed. There is very considerable erosion along the water line, upstream face, and at the bottom of the wing walls on the inside face. The entire downstream face of the spillway is eroded and quite rough. See sketch and photos for more detail.

6. The water in the lake should be lowered about 3' so that the damaged masonry at the water line on the upstream face, the entire face of the spillway and the lower part of the wingwalls ~~can~~ be cleaned up and the structure restored by pouring new concrete. See sketch indicating possible method of making repairs. A few feet outside the lower end of the east wingwall there is what appears to be the top of a gate valve on a drain thru the dam. The valve might be 10" or 12" in diameter; neither end of the pipe is visible. The valve is covered by a badly disintegrated concrete enclosure perhaps 4' x 7' inside. The drain should be cleaned and the

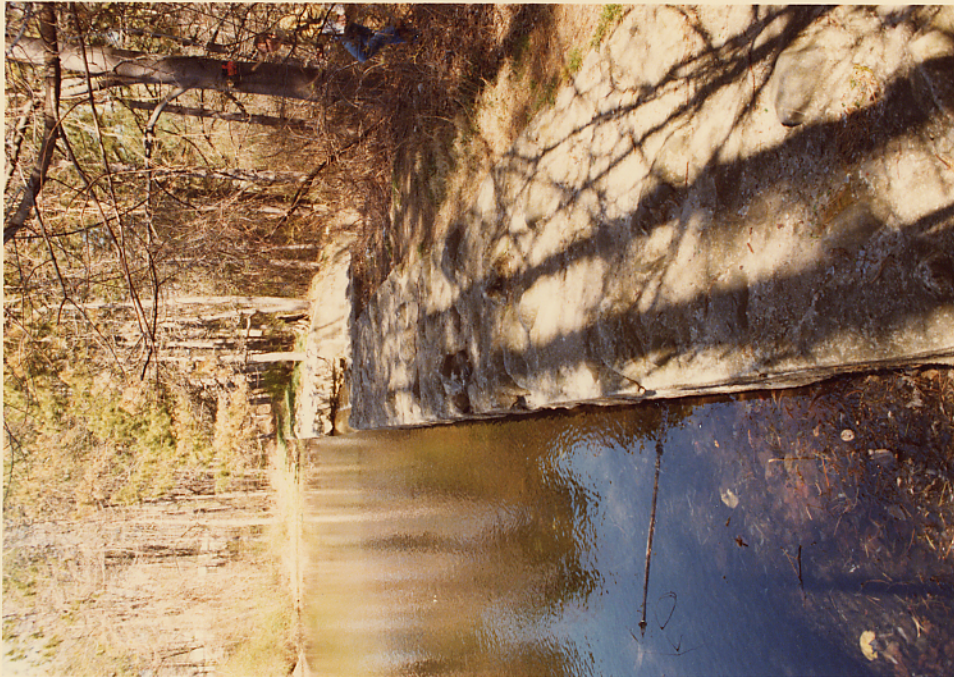
PHOTO 2  
CREST OF DAM

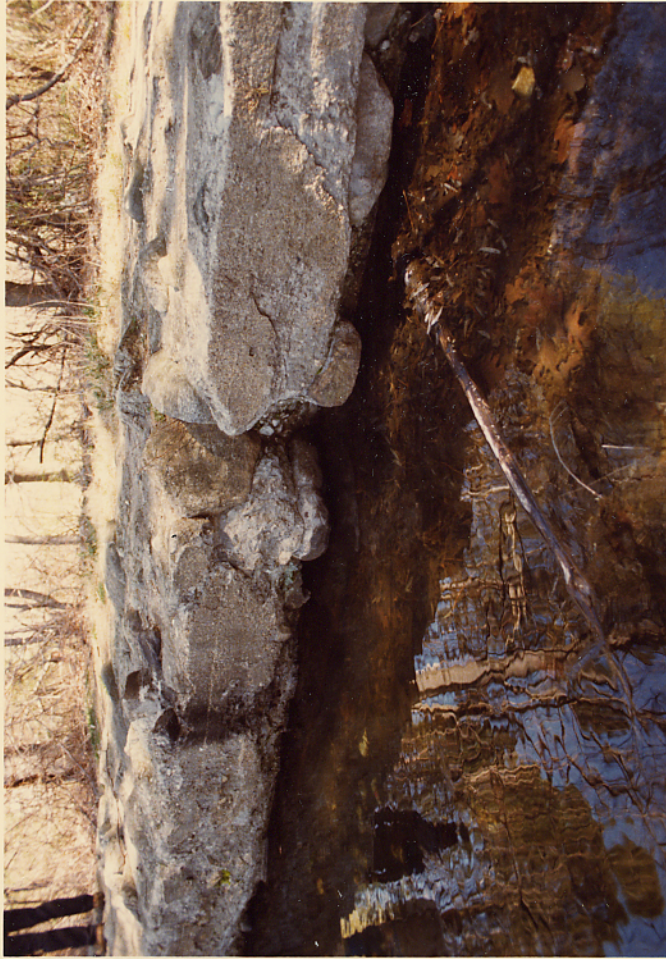
The general structural stability of the dam is good as evidenced by the vertical, horizontal and lateral alignment of the embankment. The upstream face of the dam is severely eroded and cavitated at the water line. The embankment is in good stable condition and has a good vegetative cover, however, there are some large trees growing on it. The concrete of the spillway weir, like the rest of the dam, is in poor condition. The outlet chamber is in poor condition.

PHOTO 1  
UPSTREAM FACE OF DAM

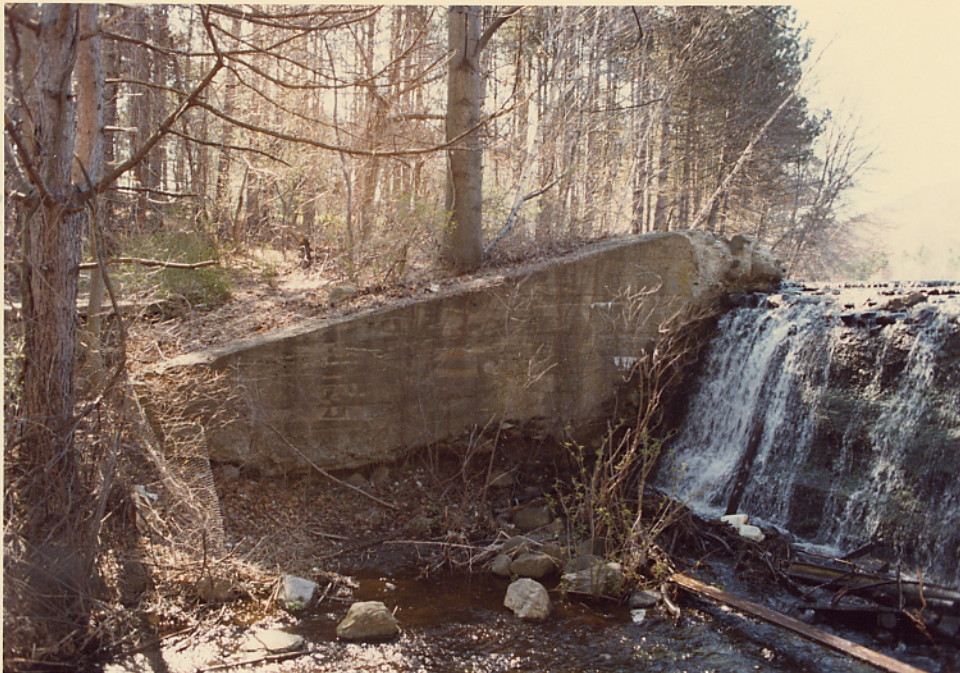
The spillway is a concrete weir that is in poor condition (Photos 3 and 5). The concrete of the spillway is eroded and cavitated. There is no approach channel. The downstream channel is a natural channel (Photo 4). Just below the spillway, brush and debris has accumulated (Photo 3).

PHOTO 3  
SPILLWAY - UPSTREAM

- (1) Spillway channel should be cleared of brush and debris.
- (2) Vegetation on the downstream face of the dam and along the toe of the dam should be removed. This will facilitate the visual observation of existing and potential seepage.
- (3) Discharge valve and pipe should be repaired. Valve for the discharge pipe should be on the upstream side of the embankment.
- (4) Concrete of the dam, spillway and training walls should be repaired.
- (5) Plans for a regular program of operation and maintenance of the dam should be initiated.
- (6) Plans for around-the-clock surveillance should be developed for periods of unusually heavy rains and a formal downstream warning system should be put into operation for use in the event of an emergency.
- (7) A program of annual technical inspection should be established.

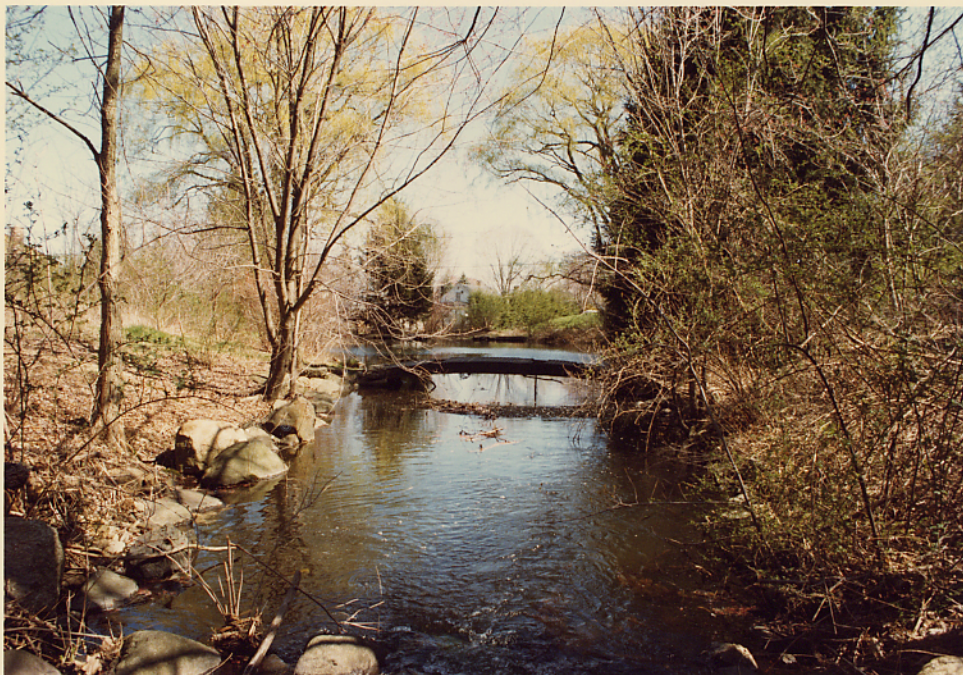
PHOTO 4  
VIEW LOOKING DOWNSTREAM

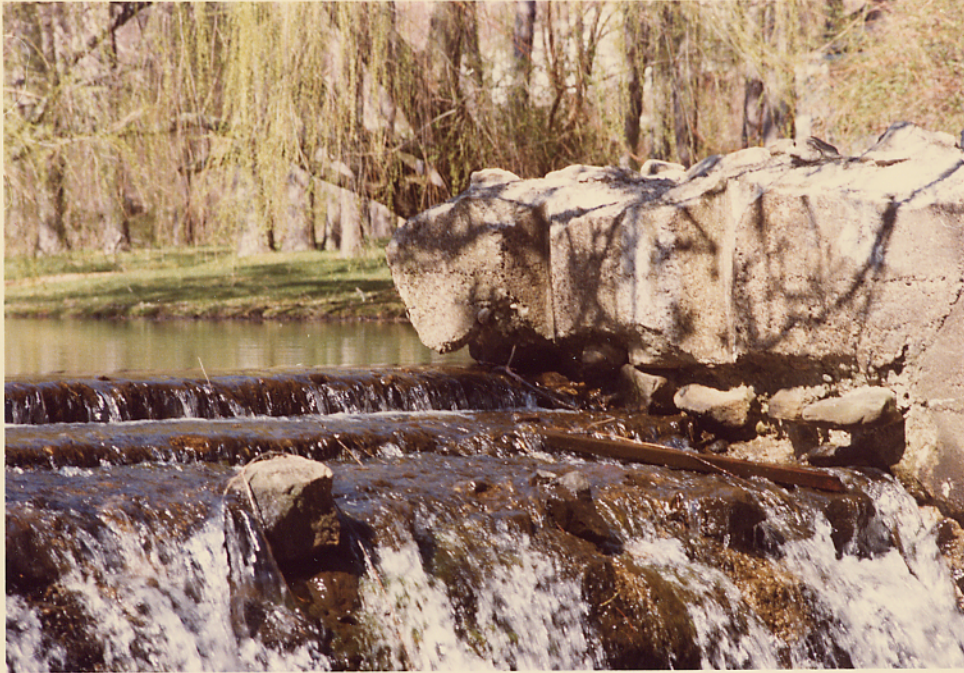
PHOTO 5  
CONCRETE CAVITATION AT SPILLWAY

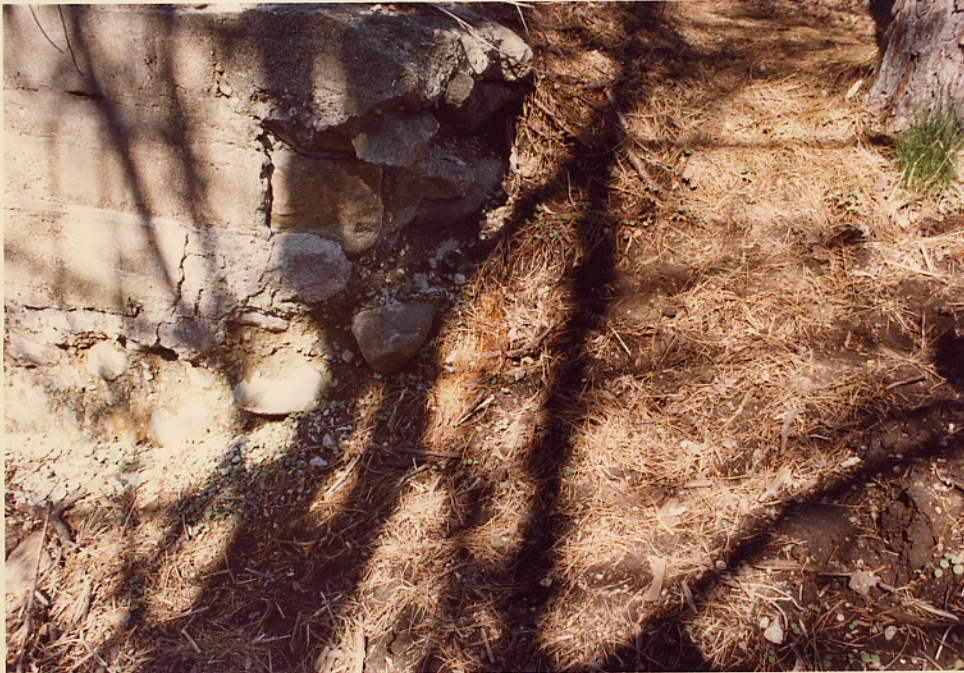
Some possible problem areas are seepage around the spillway training walls, through the gate chamber floor and the poor condition of the concrete.

PHOTO 6  
SEEPAGE AT TOE OF SPILLWAY WINGWALL

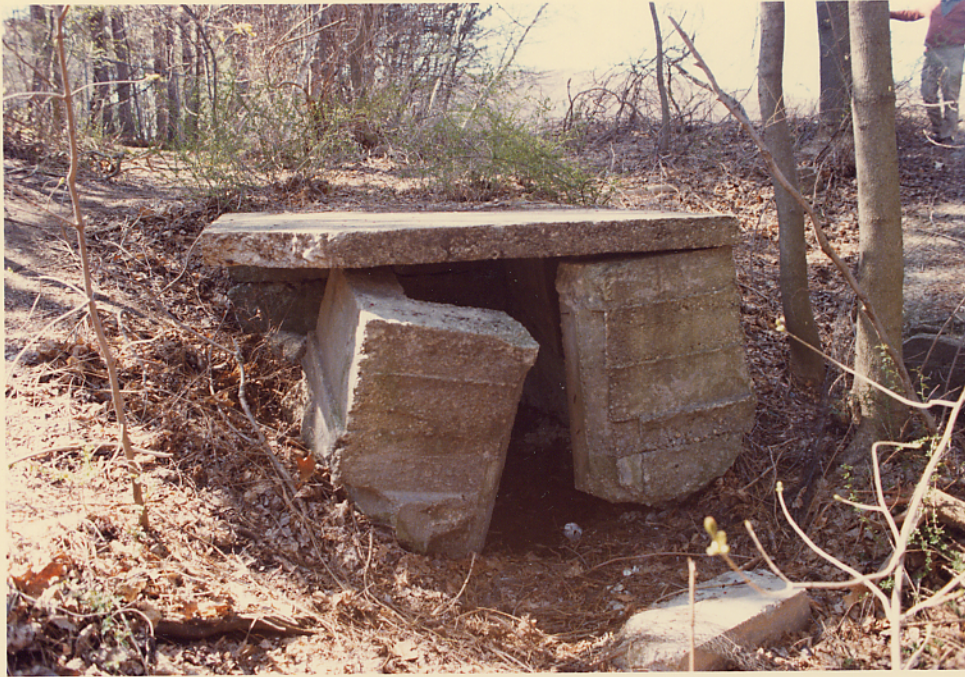
c. Appurtenant Structures - The lower gate house (Photos 7 and 8) is in poor condition with the walls and roof slab falling in. The valve inside the house is frozen closed and not operating. There is also some seepage coming

PHOTO 7  
GATE HOUSE

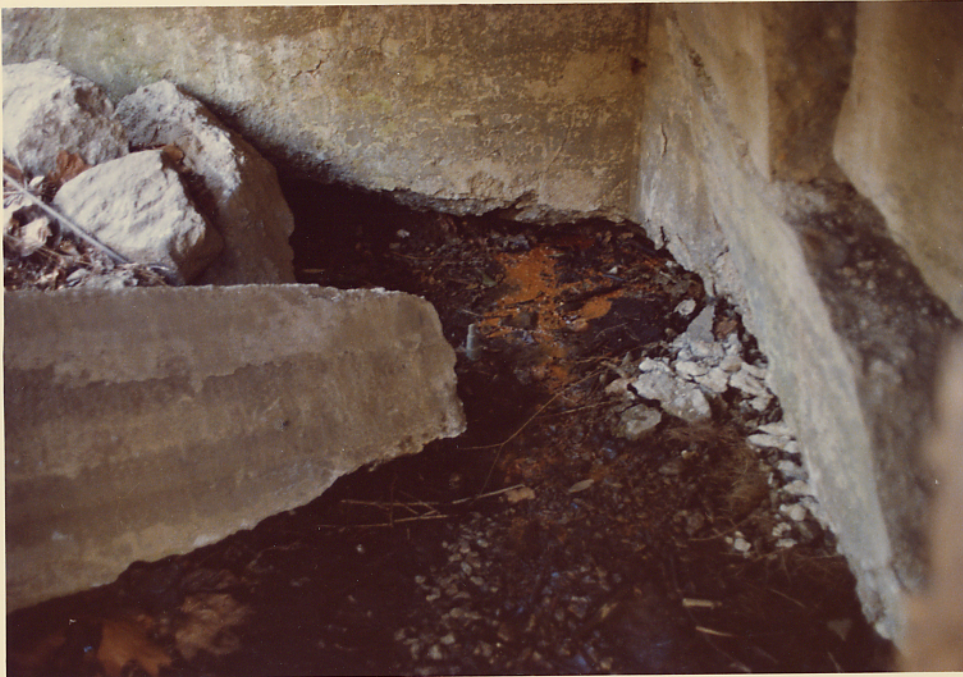
through the dirt floor of the gate chamber (Photo 8). The amount of flow is negligible. The seepage is a rust color which would indicate it is coming from the discharge pipe or valve.

PHOTO 8  
SEEPAGE - INSIDE GATE HOUSE
